CITY OF HOLLAND (city of)
OTTAWA COUNTY, MICHIGAN

FEASIBILITY STUDY
FLOATING TIRE BREAKWATER
FOR
KOLLEN PARK

OCTOBER, 1986

PREIN & NEWHOF
ENGINEERS — SURVEYORS
ENVIRONMENTAL & SOILS LABORATORIES

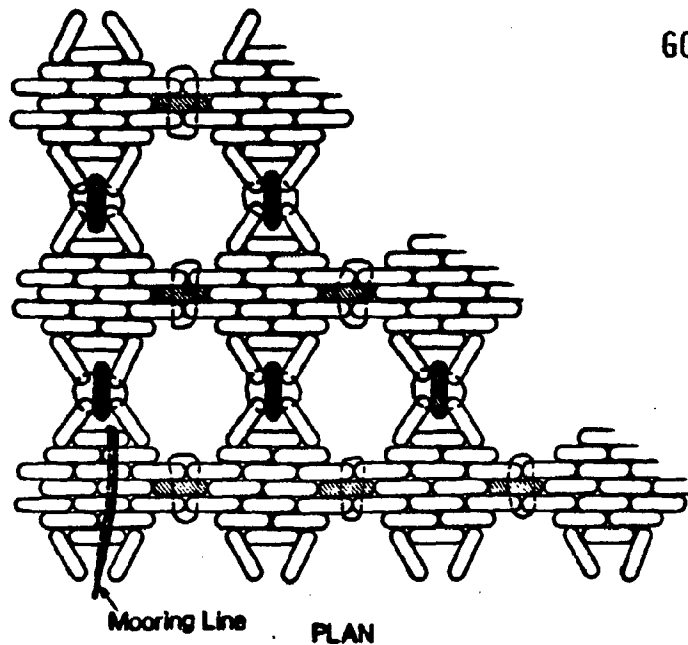
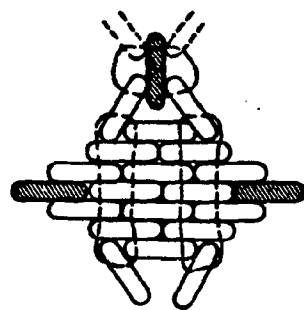
FIGURE 1

The Goodyear design (Figure 1 page 3A) consists of 18 tire modules connected together to create a breakwater of most any dimensions. The modules are connected by the same type of belting used to secure tires within the module. The breakwater is held in place by mooring lines connected to anchors to hold the breakwater in location. The windward anchors are typically much closer spaced or heavier than leeward anchors.

Note: each tire equipped with some form of supplemental flotation, tires shown cross-hatched interconnect modules
